OF  
WORLD TRADE CENTER PORTFOLIO

CENTRAL PLANT

Re: Due Diligence Physical Condition Survey  
World Trade Center  
New York, New York

**REPORT OF  
DUE DILIGENCE PHYSICAL CONDITION SURVEY  
WORLD TRADE CENTER**

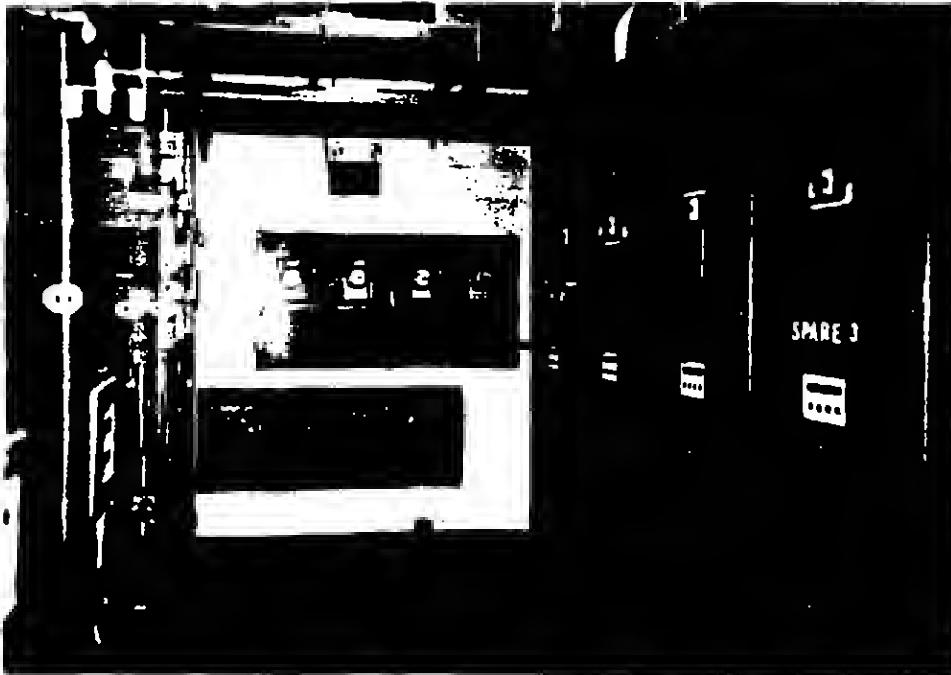
Photograph 17

Switchgear  
within the  
Primary  
Distribution  
Center

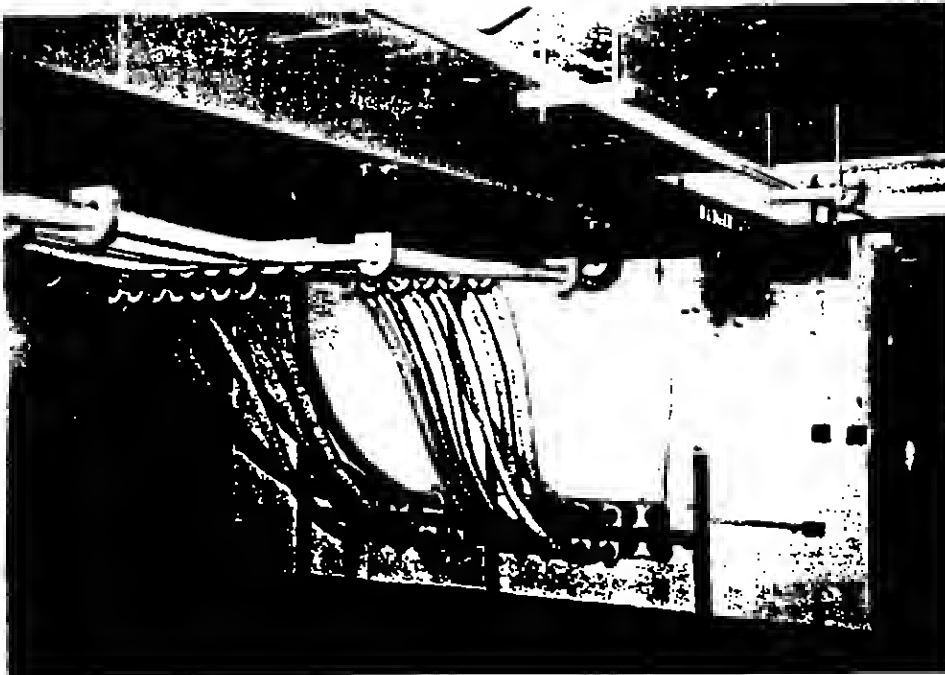
Photograph 18

Recently  
upgraded high  
voltage feeders

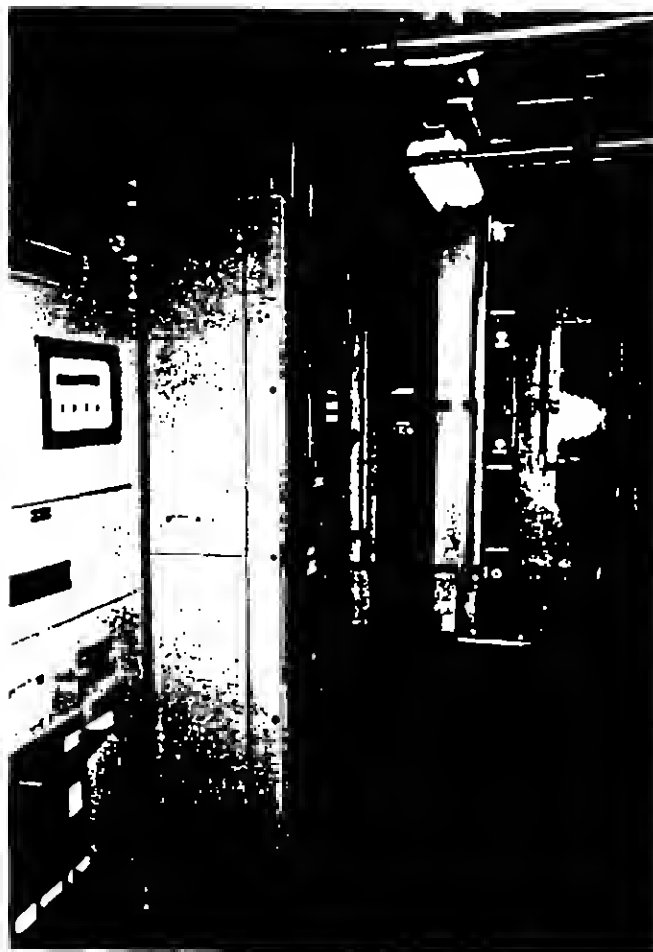
Photograph 20

Electrical  
distribution bus  
ducts (new and  
old) from a  
substation
